芦山地震单开间砌体结构房屋震害特征*

摘要: 4.20芦山地震灾区临街自建单开间砌体结构房屋震害特别严重, 本文基于现场调查研究该类特殊房屋的建造习惯、震害特征与损伤机理, 研究表明: 单开间砌体房屋是芦山地震灾区等四川小城镇比较常见的临街建筑模式, 其平面狭长, 建造随意, 结构体系不合理, 构造措施不到位, 抗震能力弱; 芦山地震地震烈度8、9度灾区单开间砌体房屋底层纵墙剪切破坏, 普遍出现严重的贯通整片墙体的斜裂缝或X形裂缝。底层前部房间横墙无纵向支撑, 独立墙段过长, 横墙压弯破坏出现贯通整片墙体的水平裂缝, 并且墙体外鼓; 结构刚度中心与质量中心严重偏离, 房屋扭转震动加剧墙体裂缝开展, 相邻建筑反复碰撞作用是上部楼层震害的主要原因; 鞭梢效应加重突变楼层结构损伤, 引起出屋面附属建筑严重破坏甚至倒塌, 横墙端部剪切断裂乃至溃散。据此, 提出了既有单开间砌体房屋加固工作的建议。

Analysis on Damage Characteristics of Single-bay Street Farmhouses in Lushan Earthquake

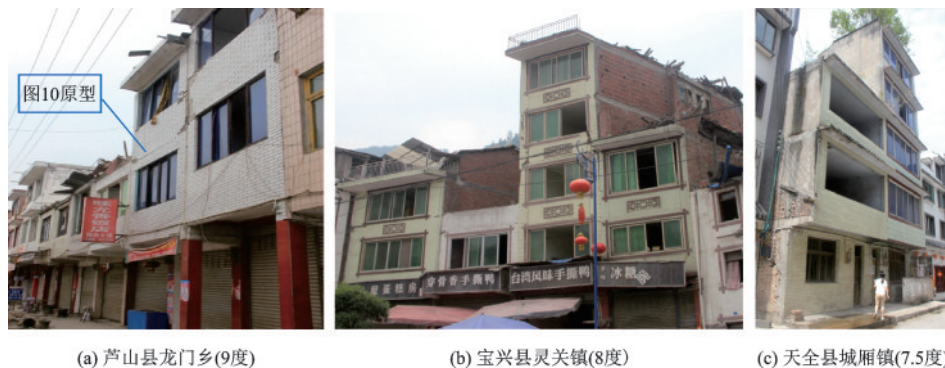
芦山地震后,课题组多次调查发现自建临街单开间砌体房屋震害非常严重,图1(a)、(b)整条街道被摧毁,损毁率达100%。这种房屋均是2000年后修建,具有商业、居住等功能,建筑性价比较

图1 芦山地震单开间临街砌体房屋震害照片(2013年)

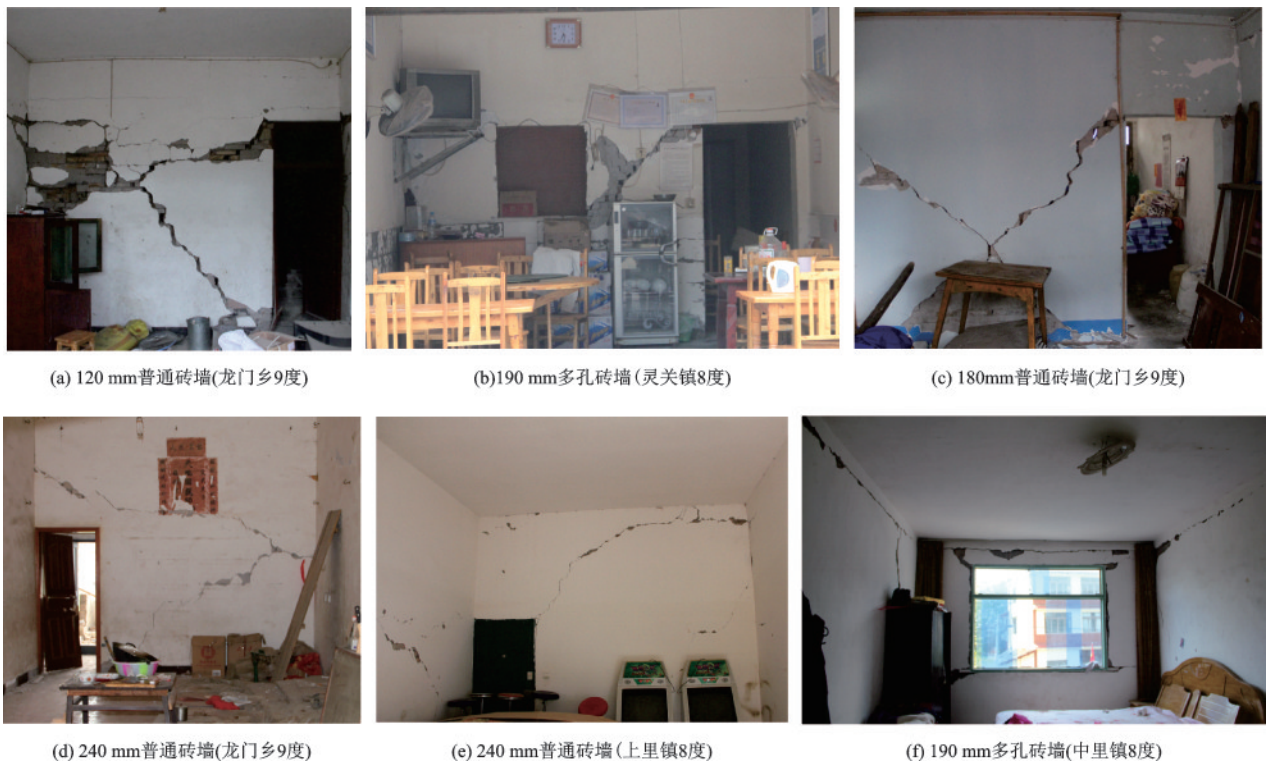
芦山地震纵墙震害照片如图4所示,主要是剪切破坏,8、9度烈度区普遍出现严重的贯通整片墙体的斜裂缝或X形裂缝,且裂缝局部酥碎。对比可见裂缝的大小和形状与地震烈度、洞口尺寸、墙体厚度、开间、层高等密切相关;墙体越厚、洞口越小(少),震害则越轻,如图4(a~e)所示;图4(a)中120 mm的普通砖墙与图4(b)中开设两个洞口的190 mm多孔砖墙,其裂缝发育程度显著高于其他墙体;外纵墙开大窗洞,窗边墙更易损坏,如图4(f)所示。从图3可以看出,单开间砌体结构房屋纵向仅靠内

部隔墙承受水平地震作用,纵墙间距较大且墙体厚度薄,尤其是底层商铺内纵墙从属荷载面积大,纵向刚度较差,抗剪承载力不足是其震害的主要原因。

图4 纵墙震害现场照片

基于上述震害特征,建议对设防烈度7度以上地区三层以上的既有单开间农房采取必要的加固措施。结合“经济、合理、有效、实用”的原则^[15],建议单开间农房加固应重点关注以下几点:(1)在纵墙与外横墙交接处、楼梯四角等采用钢筋网片现浇砂浆带或者其它方式增设构造柱,约束墙体增强整体性;(2)底层墙厚为120~180 mm的内纵墙采用钢筋网片现浇砂浆加固增厚至240 mm,提高其抗剪承载能力,减少层间位移;(3)外纵墙门洞和窗洞附近加厚墙体或增加抗侧力构件,调整房屋刚度中心与质量中心尽量重合,减轻扭转震动;(4)横墙厚度为180 mm,层数超过四层的建筑必须设法将底层墙厚增加至240 mm,保障其稳定承载能力;(5)加强局部突出屋顶连接构造,提高承载力,减少鞭梢效应损伤。

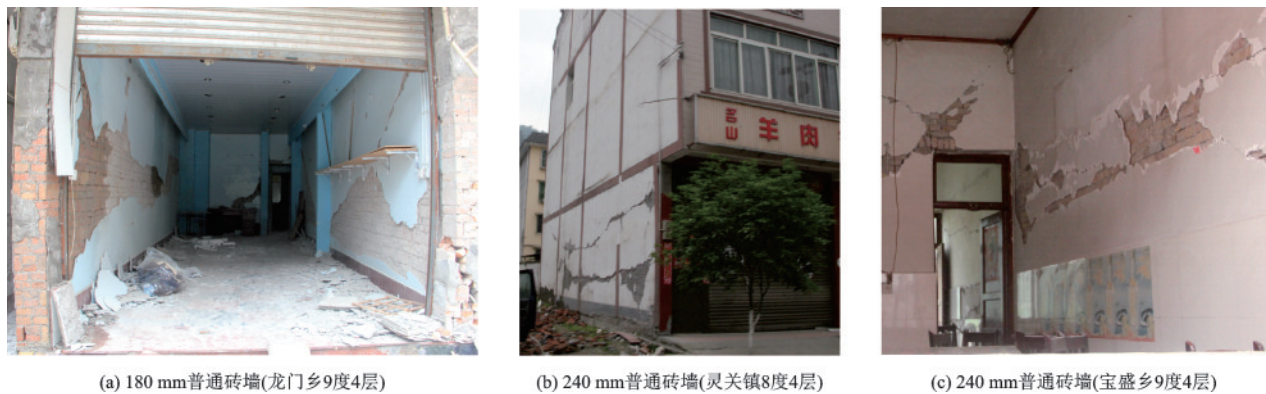
横墙是单开间砌体房屋的承重墙,最不利墙段为底层商铺,农民为扩大商业面积而增大房间进深,导致横墙无纵向支撑,独立墙段过长,甚至达到10 m以上,如图3所示。芦山地震横墙典型震害如图5所示,墙体抗弯刚度小,稳定承载能力有限^[14],地震作用下8、9度烈度区底层普遍出现严重的贯通整片墙体的水平裂缝,并且墙体外鼓,表现为压弯破坏。对比可见,图5(a)墙厚180 mm,4层房屋荷

载致使横墙外鼓,墙面装饰层剥离,卷帘门侧柱脚局部压碎;图5(b)、5(c)墙体厚度增加,裂缝略有减轻,底层层高中部墙体反复弯曲致使装饰层剥离。由于芦山地震最高烈度为9度,上述现象表明墙体稳定承载力严重不足,故该类建筑横墙考虑竖向地震作用的墙体稳定承载能力验算不容忽视。

图5 底层横墙震害现场照片

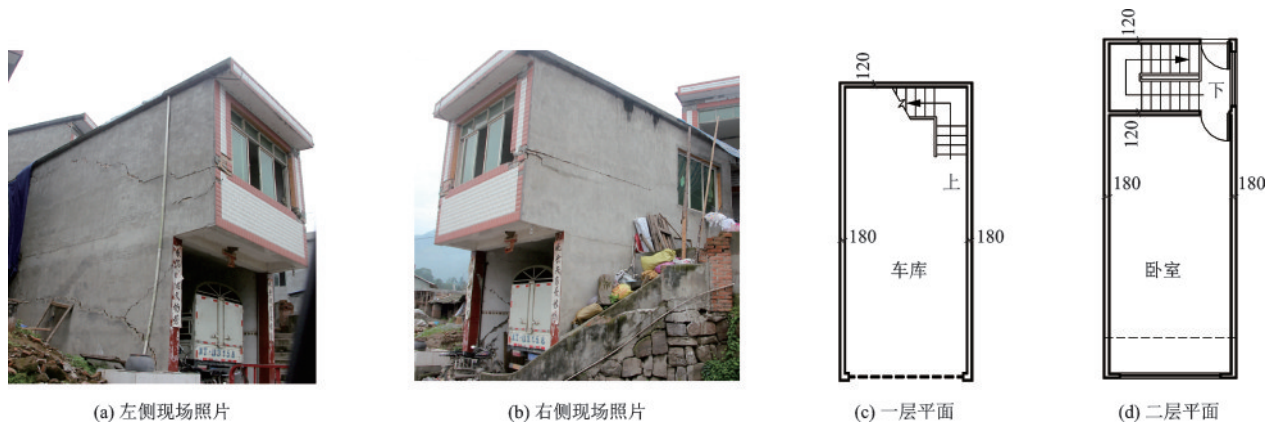
图6为芦山县龙门乡某二层单开间农房震害照片和平面布置。可见在现浇刚性楼盖、屋盖的约束扭转剪切作用下,窗下角墙体剪碎,横墙出现严重的贯通整片墙体的水平裂缝。底层左侧墙体由于楼梯中间平台的支撑导致水平裂缝发生在半层高附近并向门洞上下延伸,墙体外鼓且裂缝局部酥碎;二层左侧横墙由于楼梯间纵墙的支撑作用,裂缝从窗下角水平延伸一段后,再向后上部延伸,如图6(a)所示。底层右侧水平裂缝位于墙底和墙顶;二层右侧横墙直接从窗下角向后部水平延伸,如图6(b)所示。从平面布置图可见,该房屋楼梯间放置

在端部,底层只有尽端一片纵墙,二层两片纵墙也靠近房屋后侧布置,前端开大洞口,结构刚度中心与质量中心严重偏离,房屋的扭转震动是震害的主要诱因。

图6 两层单开间砌体房屋震害(龙门乡9度)照片和平面布置

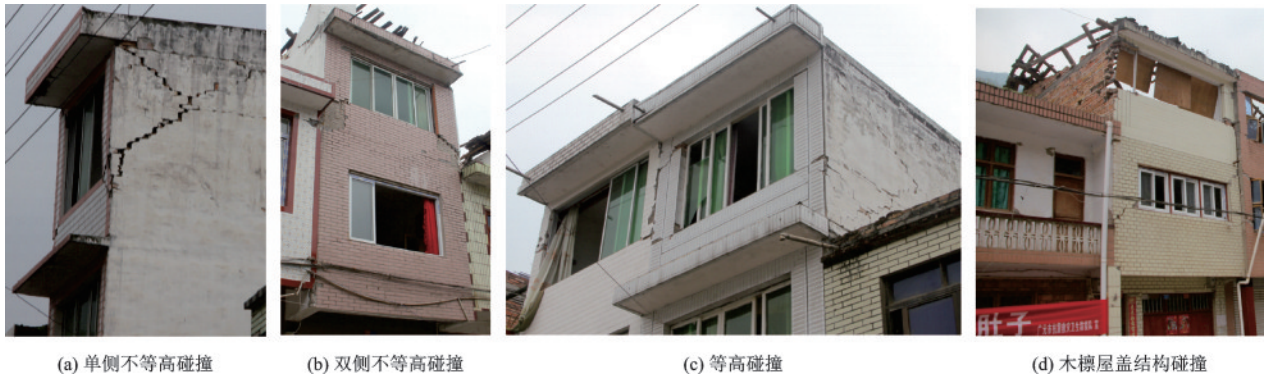
如图1、2所示,农民建房时不愿共墙,但又紧邻修建,两栋之间的间隙远远无法满足抗震缝宽度要求。图7为芦山县9度烈度区三层单开间砌体房屋的碰撞震害。可见无论单侧不等高、双侧不等高还是等高建设,单开间砌体房屋都会发生严重碰撞损伤。房屋撞击加速上部楼层扭转震动反应,刚性屋盖建筑的顶层外纵墙窗洞口处剪坏,横墙扭转剪切出现通缝且前端局部剪出,单侧不等高碰撞损伤严重于两侧均有建筑,如图7(a~c)所示;柔性木檩屋盖结构约束作用弱,导致屋盖倒塌,如图7(d)所示。碰撞损伤主要在碰撞部位相邻楼层,单开间房屋平面狭长,侧向刚度弱、变形大,墙体扭转震动和相邻建筑的碰撞冲击效应是主要诱因,刚性屋盖震害相对较轻。

图7 芦山县9度区三层单开间砌体房屋碰撞震害照片

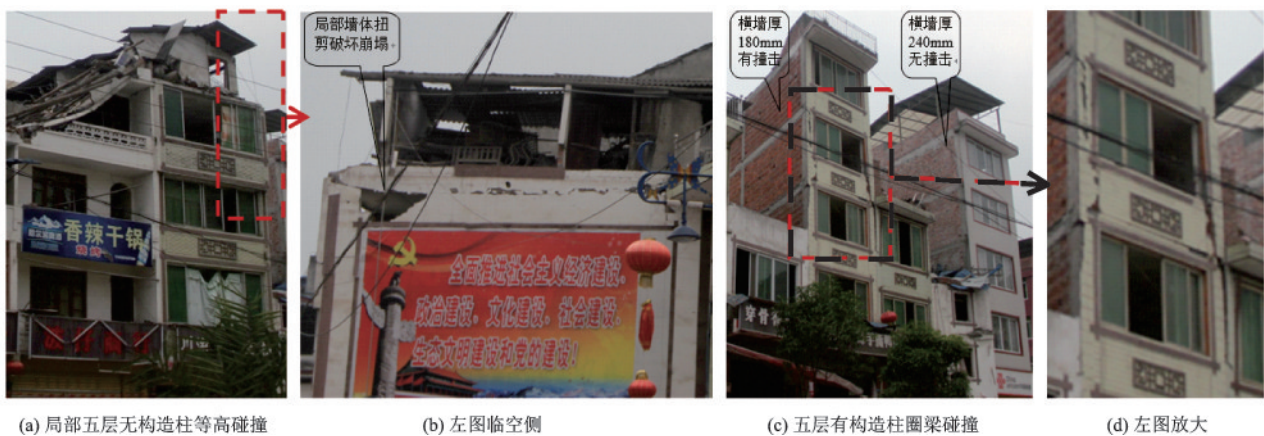
图8为宝兴县灵关镇8度烈度区单开间砌体房屋碰撞震害。可见左右撞击加速上部楼层扭转震动,5层无构造柱建筑顶层倒塌,屋顶扭转撞击震动使横墙出现水平通缝,局部墙体扭剪破坏崩塌,如图8(a~b)所示。图8(c)中两栋5层单开间砌体房屋均采用现浇楼盖并设置构造柱,可以看出左侧房屋横墙厚180mm有撞击,建筑局部突出、屋顶倒塌,三层楼面碰撞相邻构造柱断裂(图8(d)),构造柱约束墙体并没有溃散,但结构严重损坏而拆除重建;与之相邻的5层240mm厚新建墙体建筑,由于墙体厚度增加,构造柱大,结构中等损坏,目前加固后仍在继续使用。

图8 宝兴县灵关镇8度区单开间砌体房屋碰撞震害照片

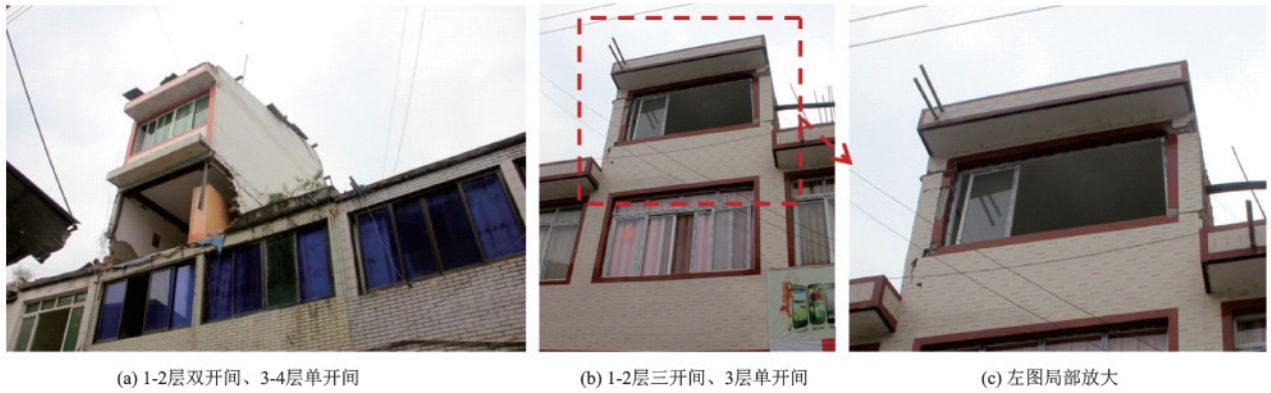
单开间砌体房屋的鞭梢效应最容易引起出屋面附属建筑严重破坏甚至倒塌,如图1、图8所示。图9(a)的建筑为1、2层双开间,为了增加建筑面积加建3、4层为单开间,未设构造柱,鞭梢效应造

成屋顶倒塌,3楼横墙端部应力集中处溃散。图9(b)中虽仅在2层局部突出增加一层单开间房屋,鞭梢效应仍然造成横墙端部剪切断裂,如图9(c)所示。

图9 鞭梢效应(龙门乡9度)

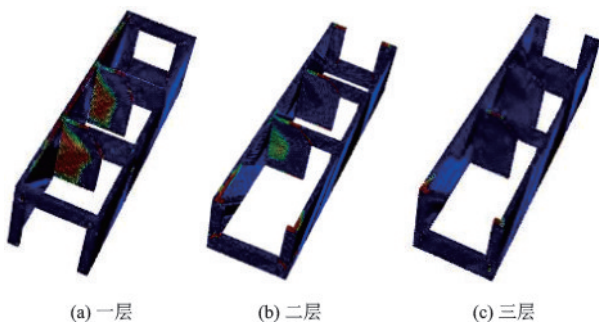
基于芦山地震现场的调查表明,7度烈度区三层单开间农房横墙、窗洞墙角就有明显剪切裂缝。选图1(a)的三层单开间农房为原型,模型参数设置、材料本构关系选择等详见参考文献[16],采用ABAQUS有限元分析0.10g(7度设防)El Centro波作用下房屋受拉损伤云图,如图10所示。可见房屋损伤与图4(e)、4(f)等震害现象吻合,即使结构布置均匀的3m开间3层楼房屋在没有碰撞的作用下,7度地震门窗洞口墙角破坏也比较显著,如果结构布置不均匀引起扭转与碰撞作用,房屋震害将更加严重。

图10 0.10g三层单开间房屋受拉损伤云图(开间3 m)
