芦山地震单开间砌体结构房屋震害特征*

摘要: 4.20芦山地震灾区临街自建单开间砌体结构房屋震害特别严重, 本文基于现场调查研究该类特殊房屋的建造习惯、震害特征与损伤机理, 研究表明: 单开间砌体房屋是芦山地震灾区等四川小城镇比较常见的临街建筑模式, 其平面狭长, 建造随意, 结构体系不合理, 构造措施不到位, 抗震能力弱; 芦山地震地震烈度8、9度灾区单开间砌体房屋底层纵墙剪切破坏, 普遍出现严重的贯通整片墙体的斜裂缝或X形裂缝。底层前部房间横墙无纵向支撑, 独立墙段过长, 横墙压弯破坏出现贯通整片墙体的水平裂缝, 并且墙体外鼓; 结构刚度中心与质量中心严重偏离, 房屋扭转震动加剧墙体裂缝开展, 相邻建筑反复碰撞作用是上部楼层震害的主要原因; 鞭梢效应加重突变楼层结构损伤, 引起出屋面附属建筑严重破坏甚至倒塌, 横墙端部剪切断裂乃至溃散。据此, 提出了既有单开间砌体房屋加固工作的建议。

Analysis on Damage Characteristics of Single-bay Street Farmhouses in Lushan Earthquake

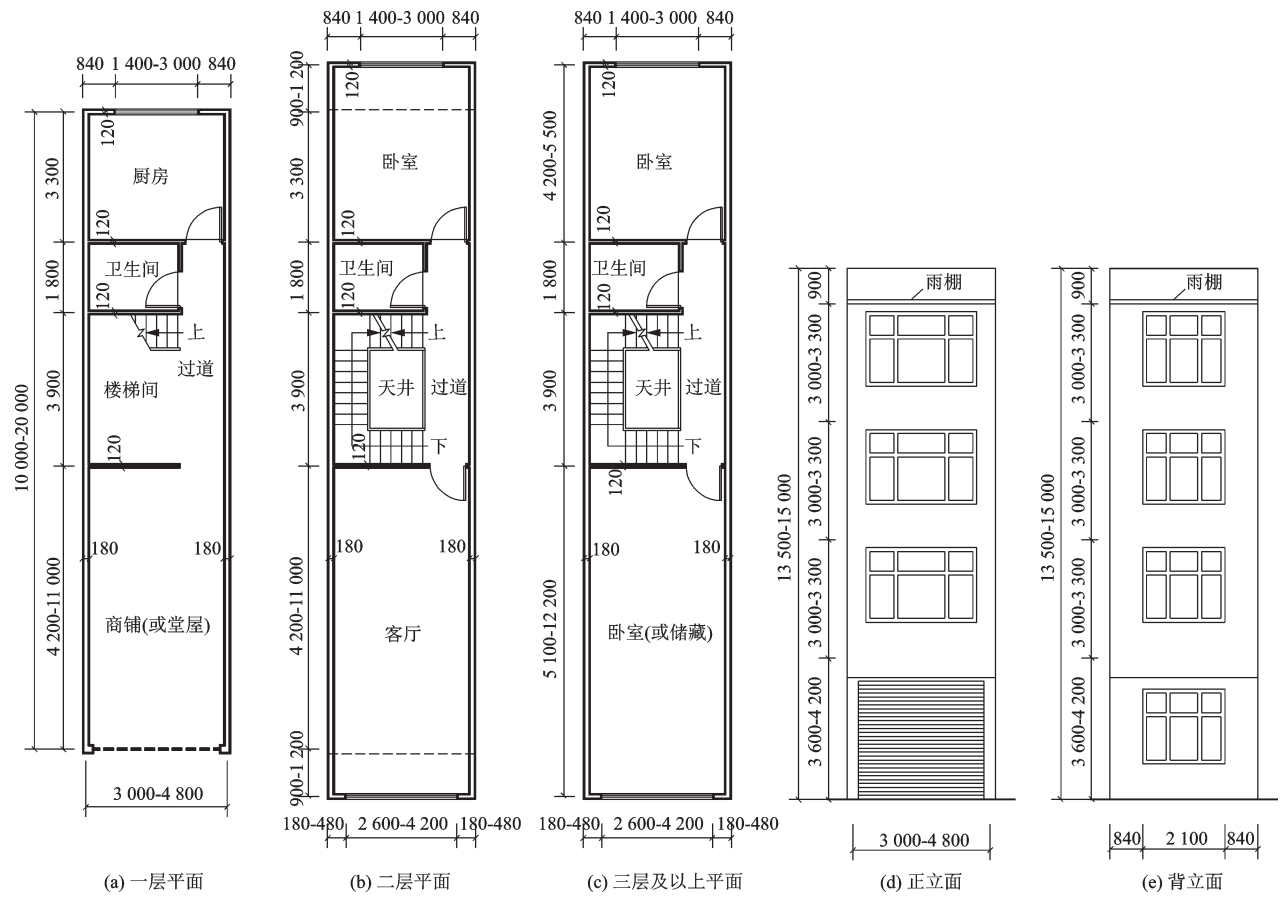
图3 常见单开间砌体房屋功能布置平面和立面

横墙是单开间砌体房屋的承重墙,最不利墙段为底层商铺,农民为扩大商业面积而增大房间进深,导致横墙无纵向支撑,独立墙段过长,甚至达到10 m以上,如图3所示。芦山地震横墙典型震害如图5所示,墙体抗弯刚度小,稳定承载能力有限^[14],地震作用下8、9度烈度区底层普遍出现严重的贯通整片墙体的水平裂缝,并且墙体外鼓,表现为压弯破坏。对比可见,图5(a)墙厚180 mm,4层房屋荷
